# San Fernando, California, Earthquake of February 9, 1971

LEONARD M. MURPHY  
*Scientific Coordinator*

*Volume I*

*Part B.* Buildings *continued*; Soils and Foundations

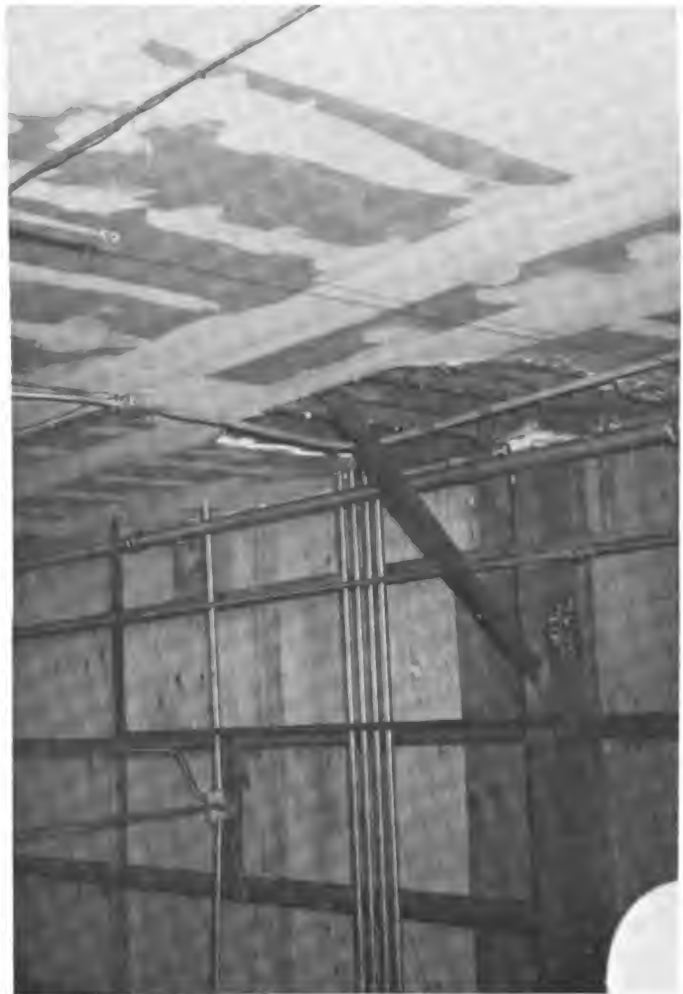
Figure 19.—Alpha Beta Market. New steel knee braces added between steel columns and tapered steel girder to improve lateral stability of building at line 5. Wheeler & Gray photograph.

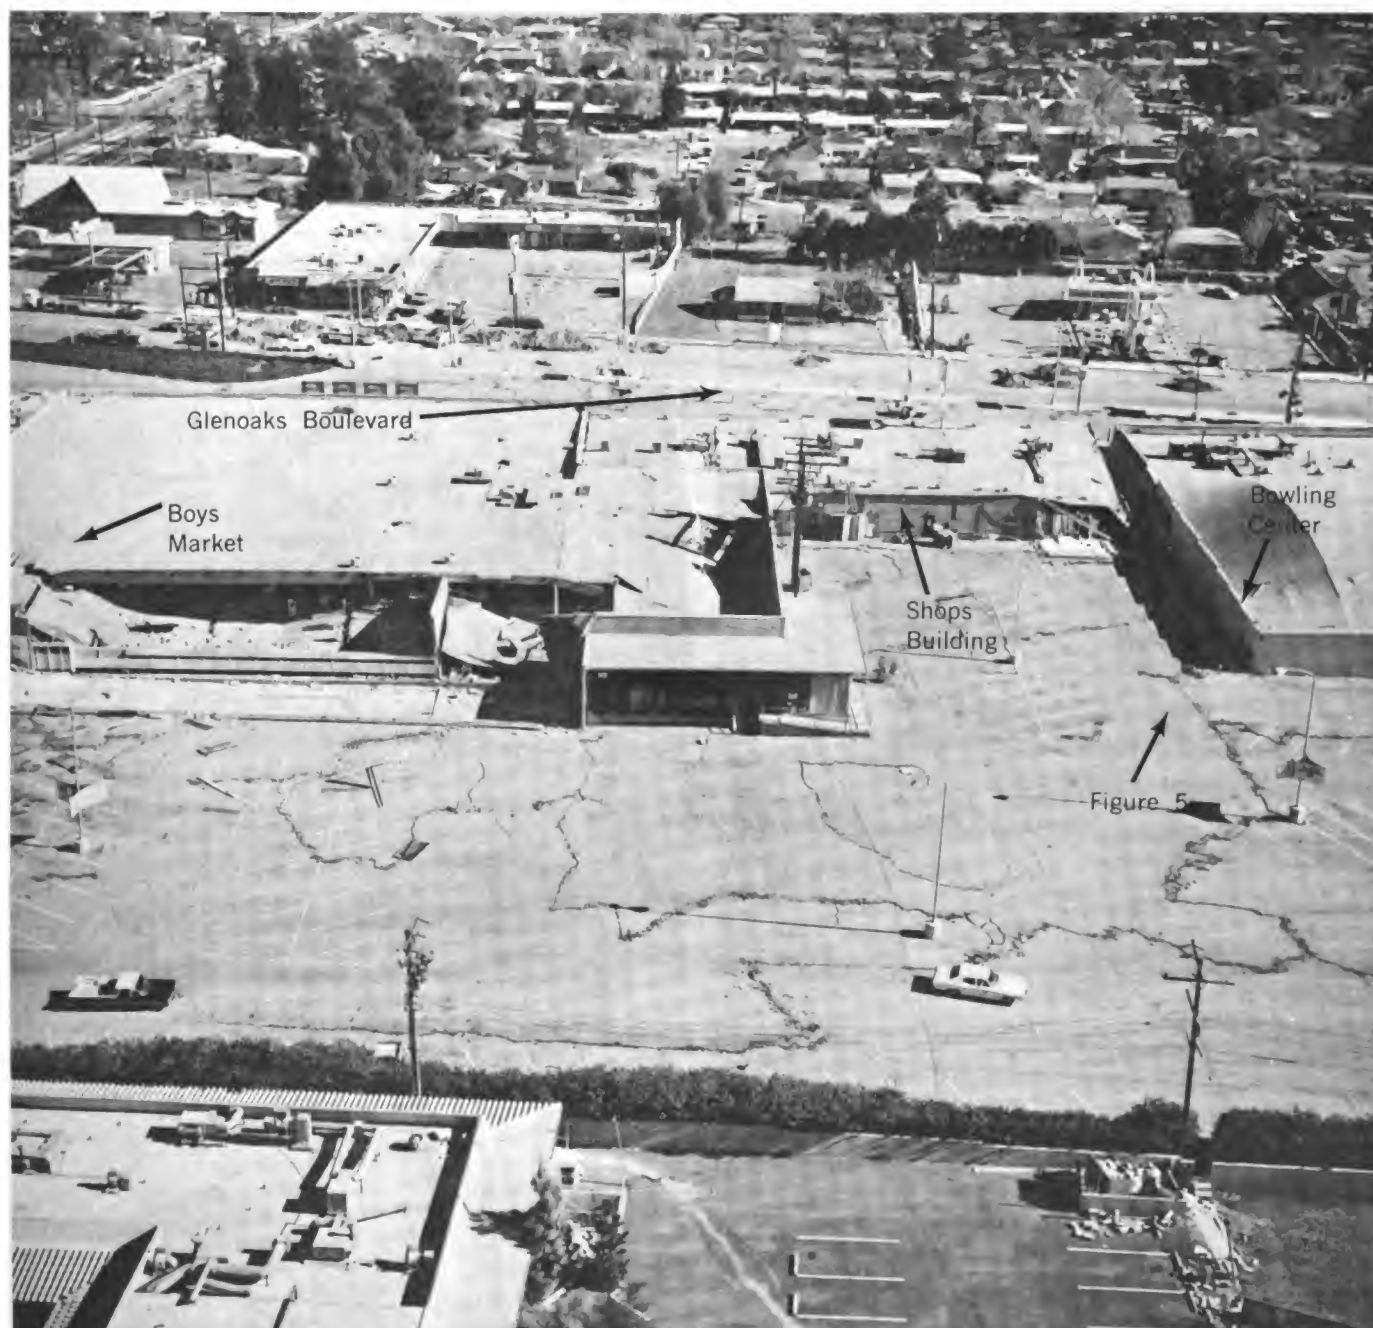
Figure 4.—Boys Market site. Looking north, showing in addition to the market, the adjacent shops building and bowling center.  
Robert E. Wallace, USGS, photograph.

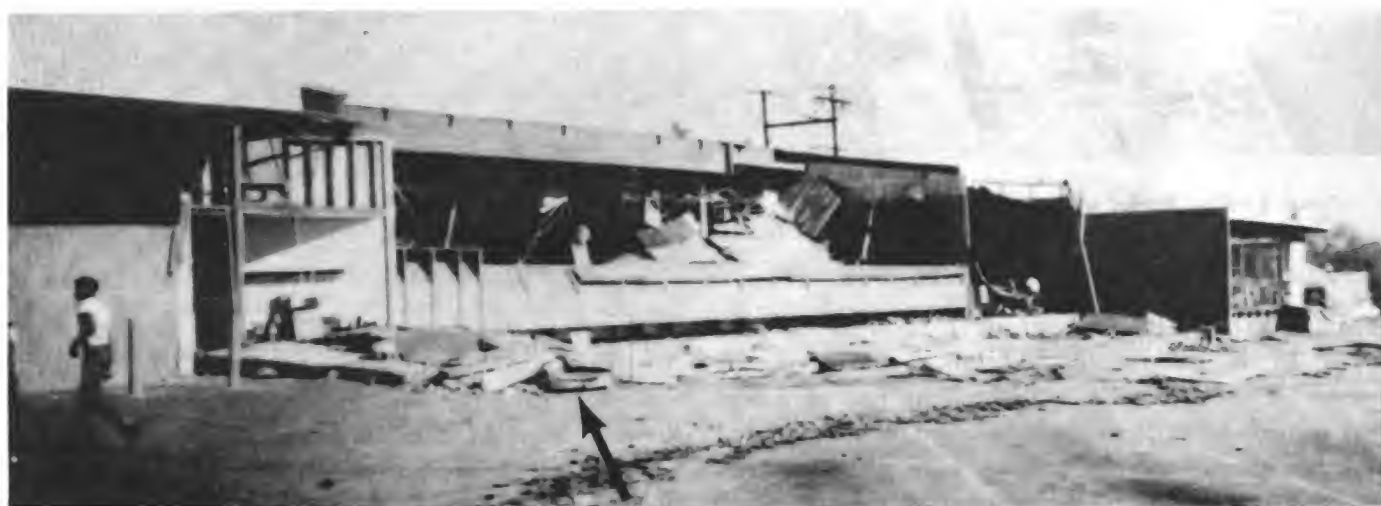
*Figure 7.—Boys Market, looking toward location of south wall. Note trunk of auto in center of photograph under fallen wall. LeRoy Crandall & Associates photograph.*

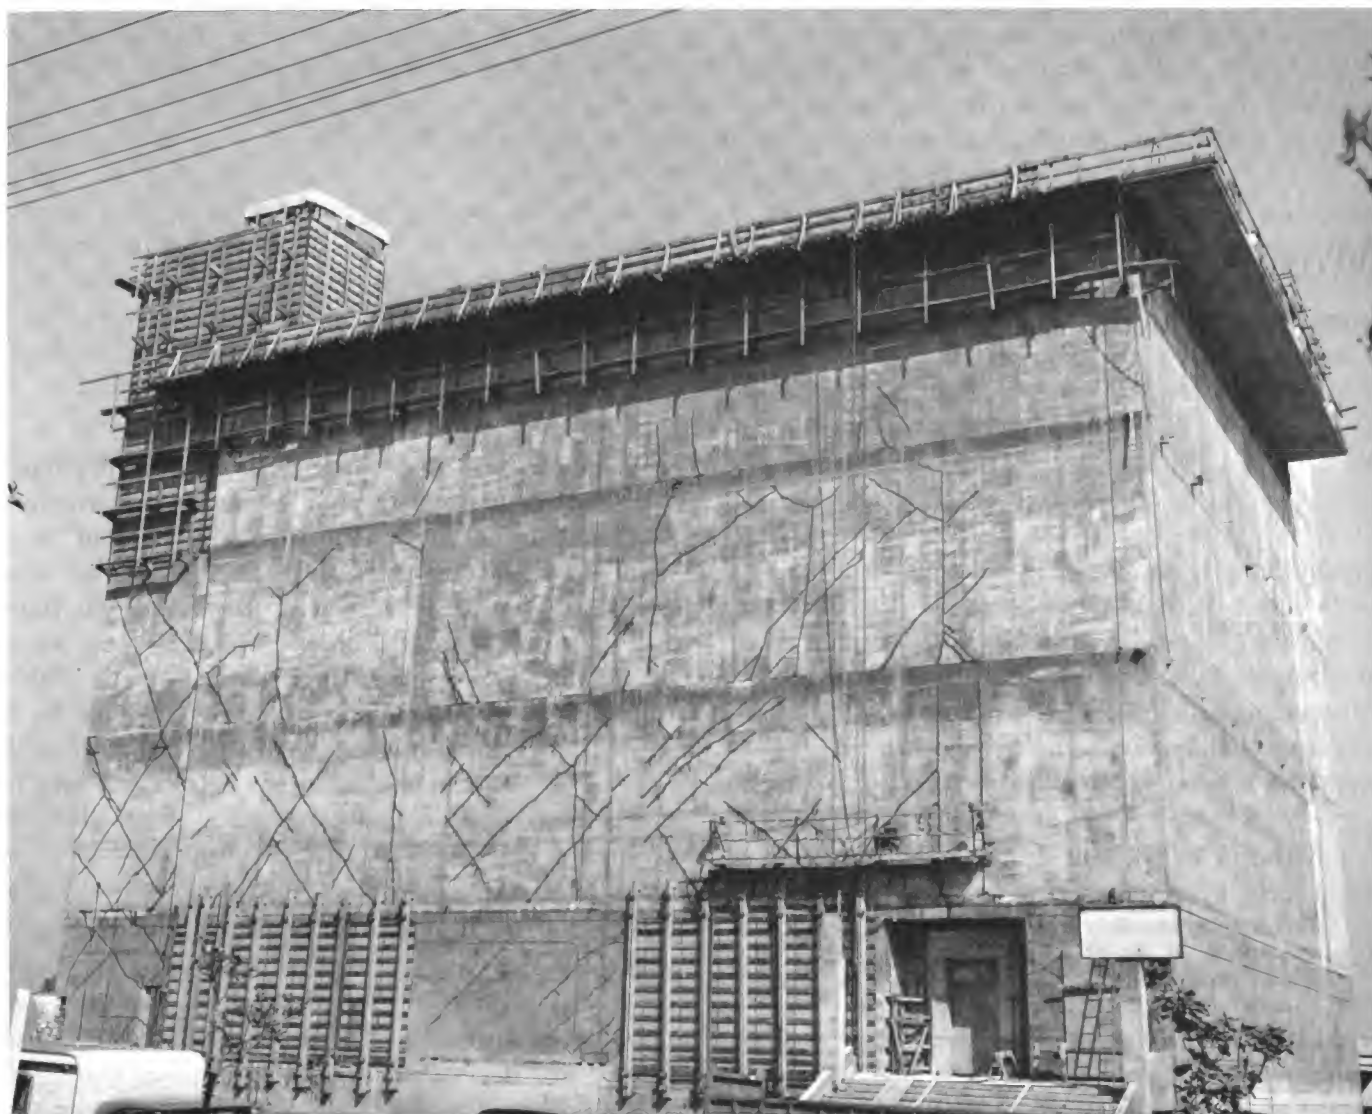
*Figure 1.—Museum for Antique Cars. Building north wall, with repair of wall cracks in progress.*

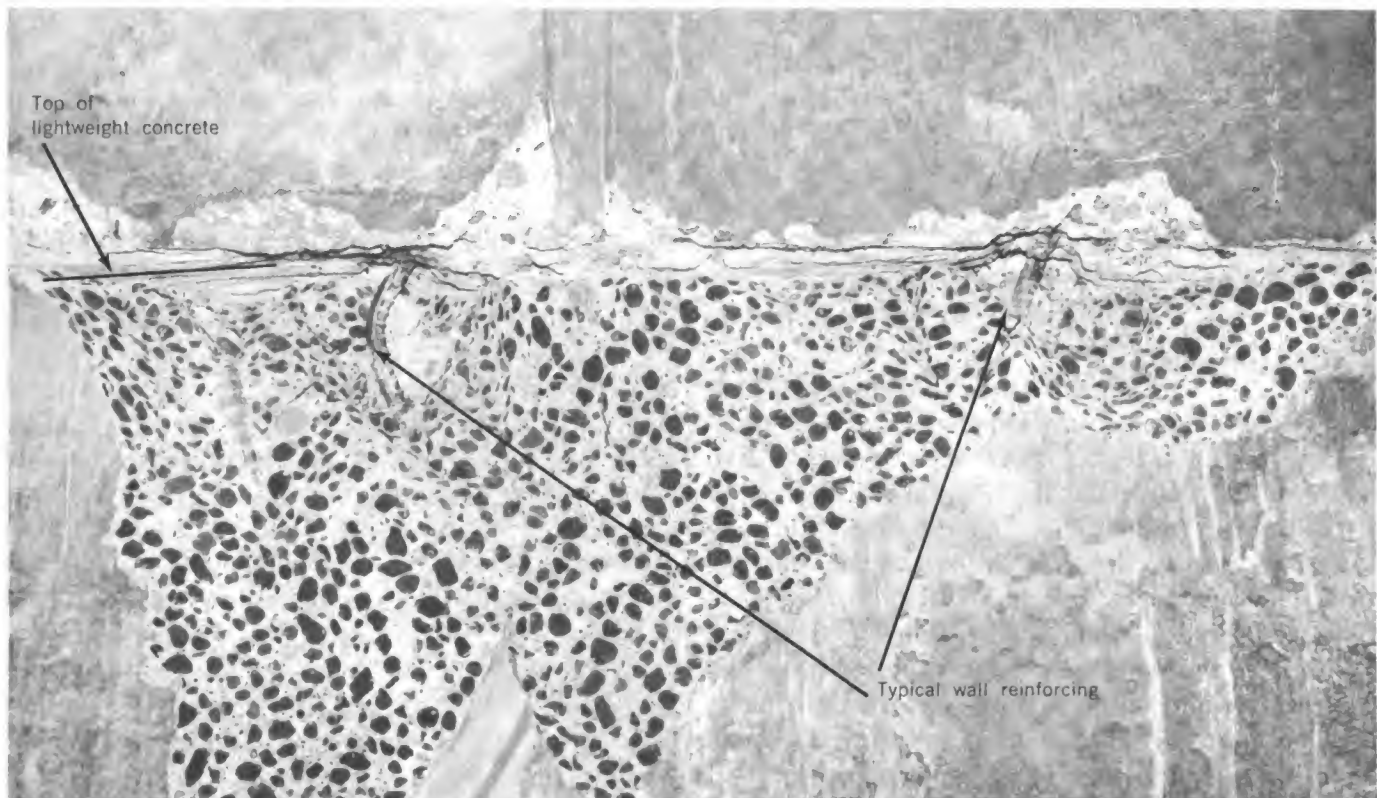
Figure 8.—Museum for Antique Cars. Fracture joint at first floor in north wall.

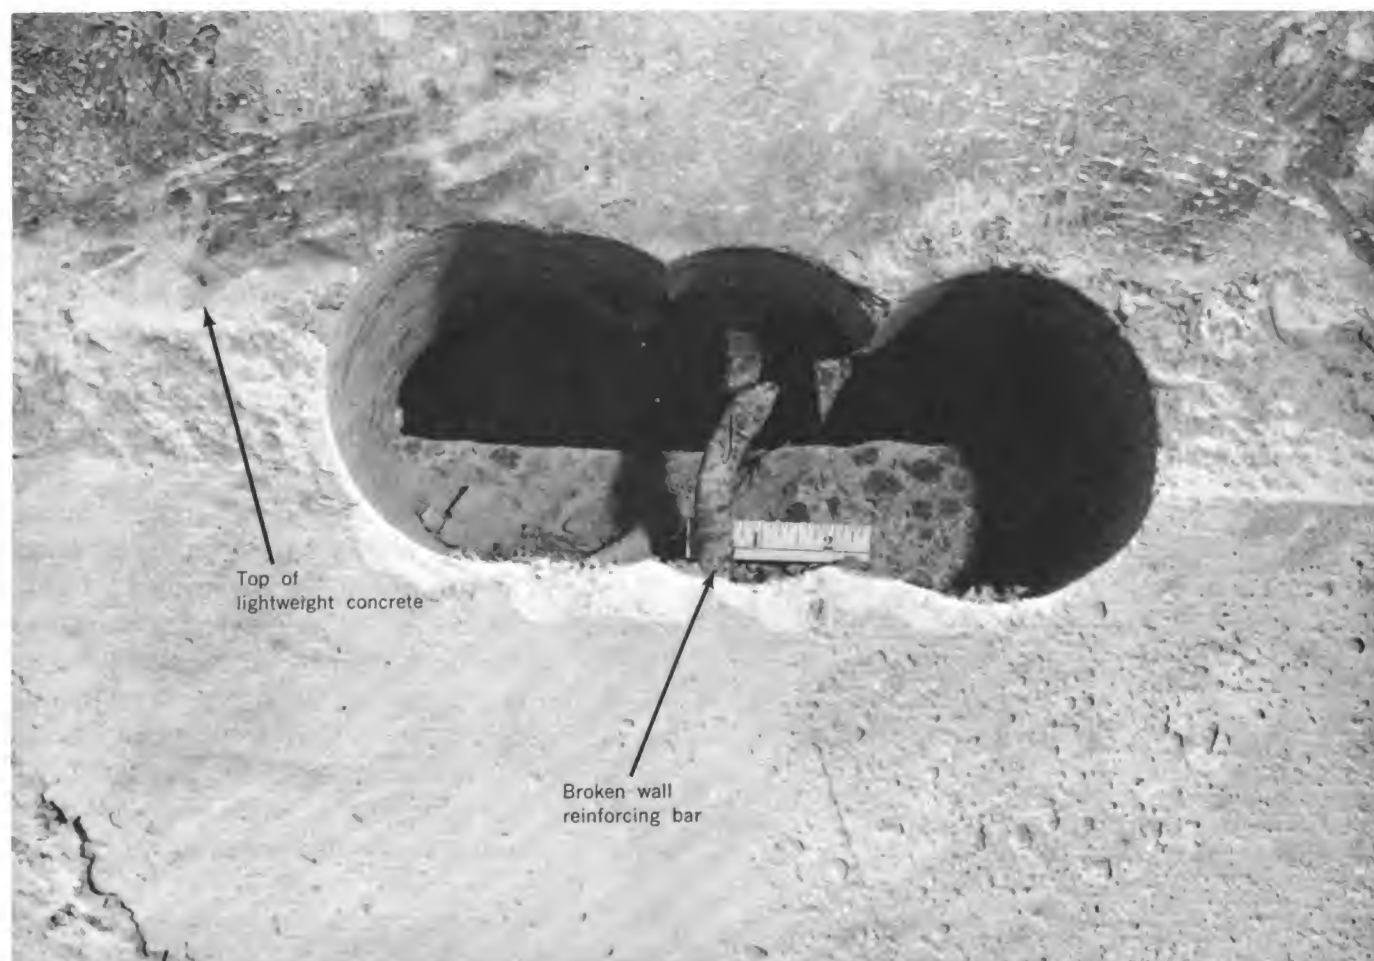
Figure 9.—Museum for Antique Cars. Typical wall reinforcing bars at first floor in north wall. Note offset of upper portion of bar to right of lower portion.

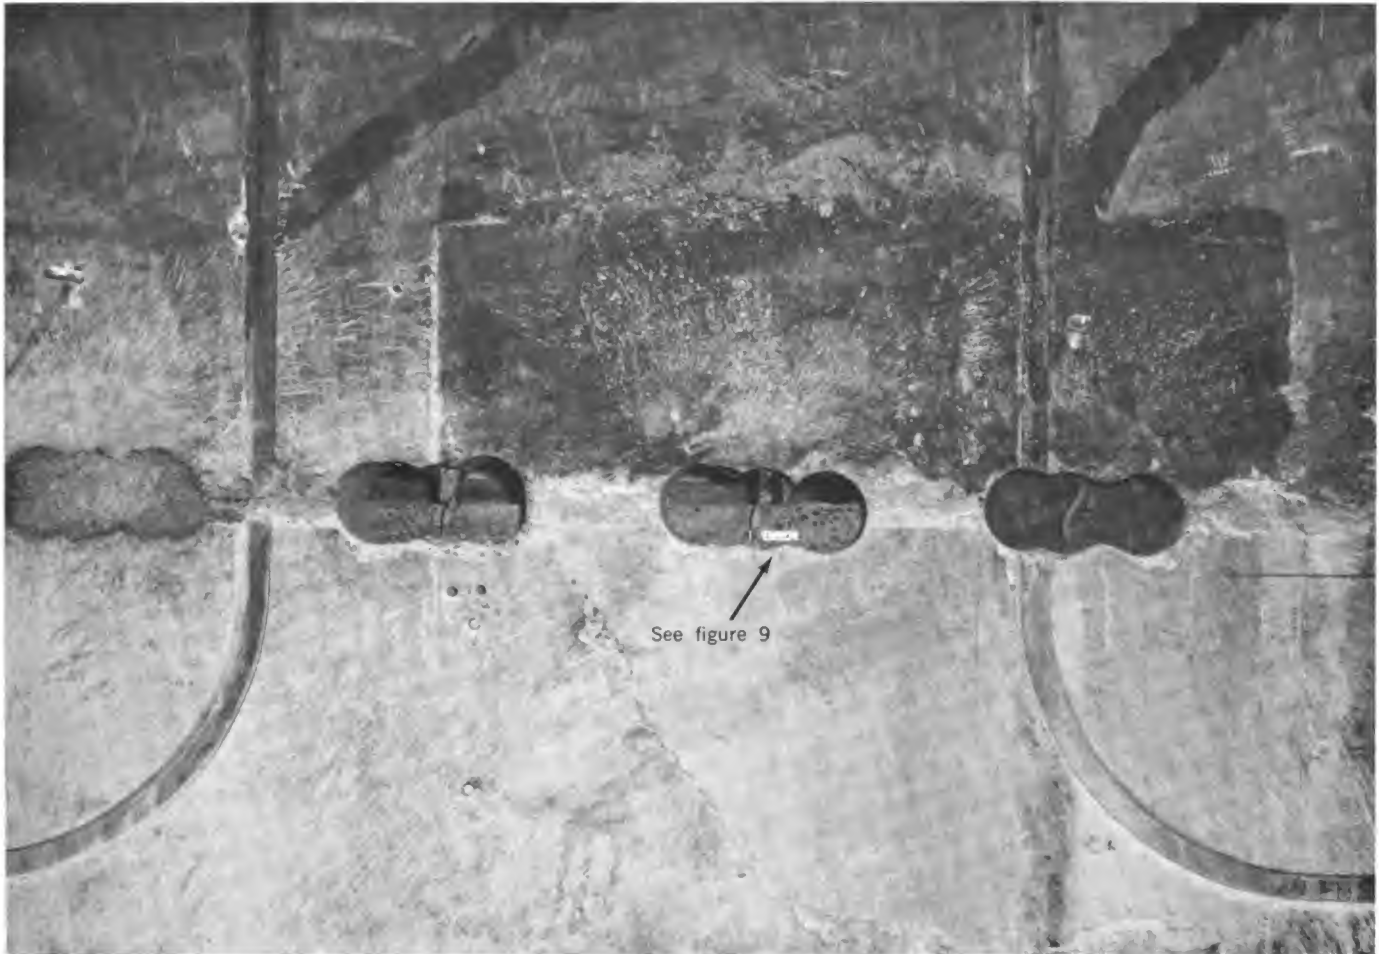
Figure 10.—Museum for Antique Cars. Typical keys cut in walls at fractured horizontal construction joints.

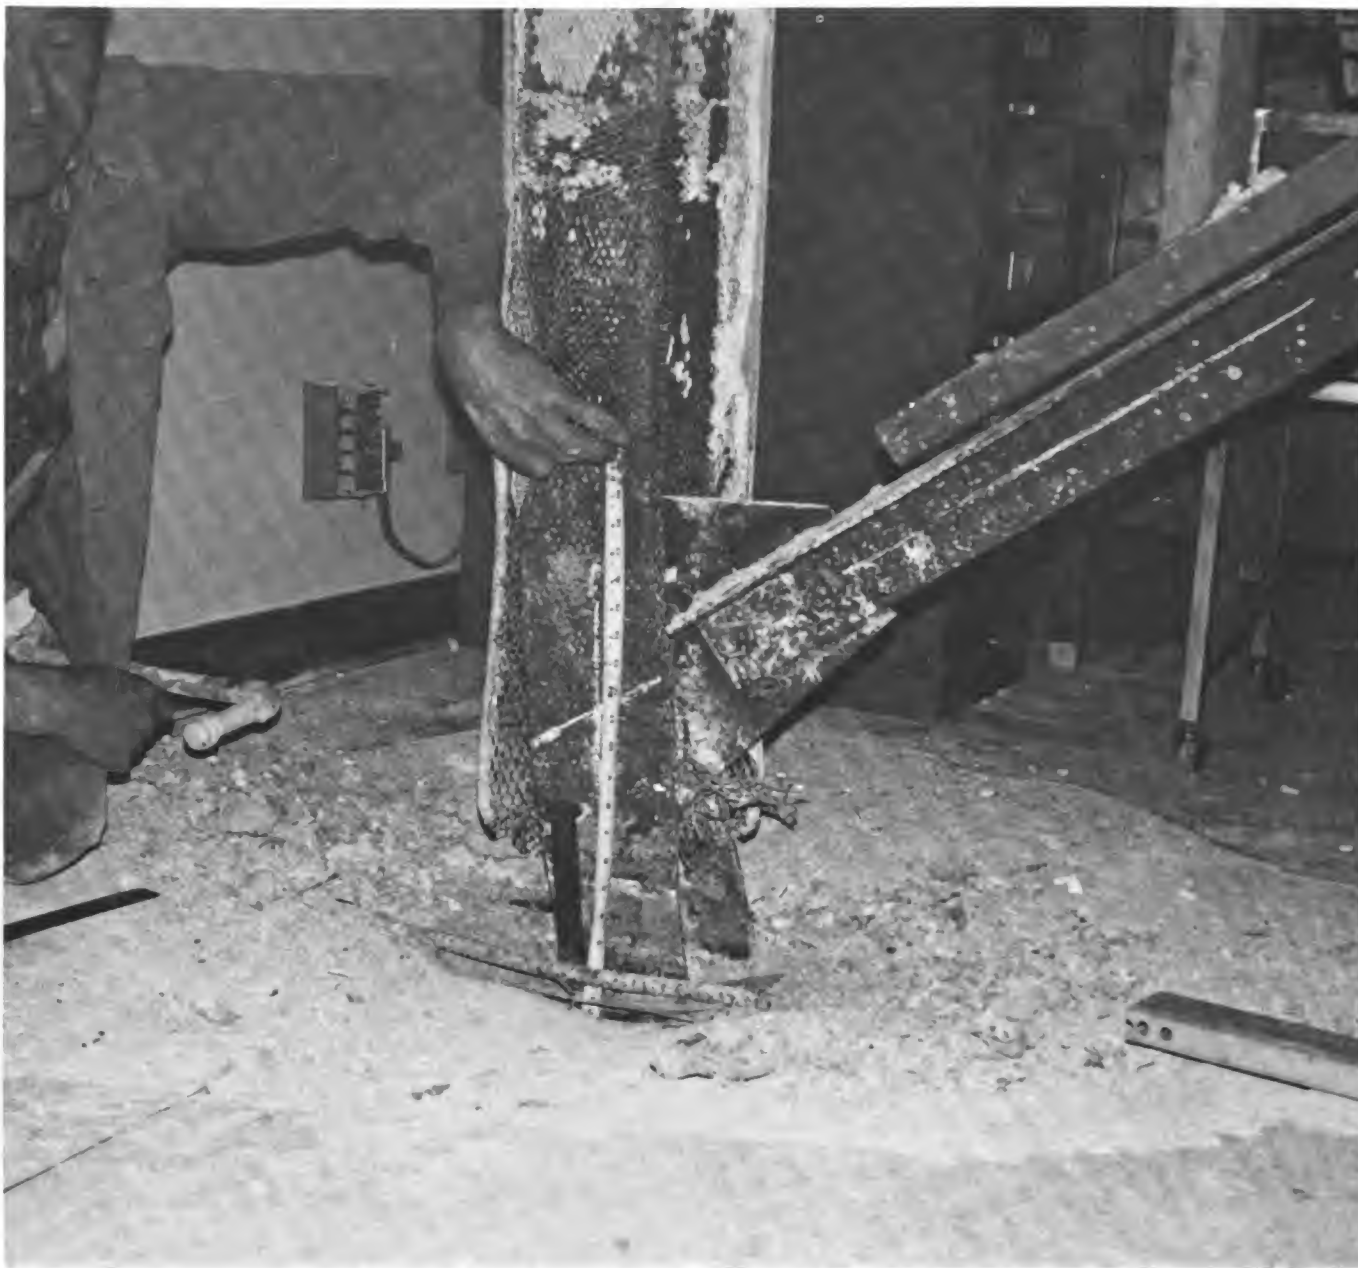
*Figure 5.—Foothill Medical Center. Base of 5WF16 column on line 3 with diagonal brace connection. Note eccentricity of brace of 11½ inches. E. E. Schader photograph.*

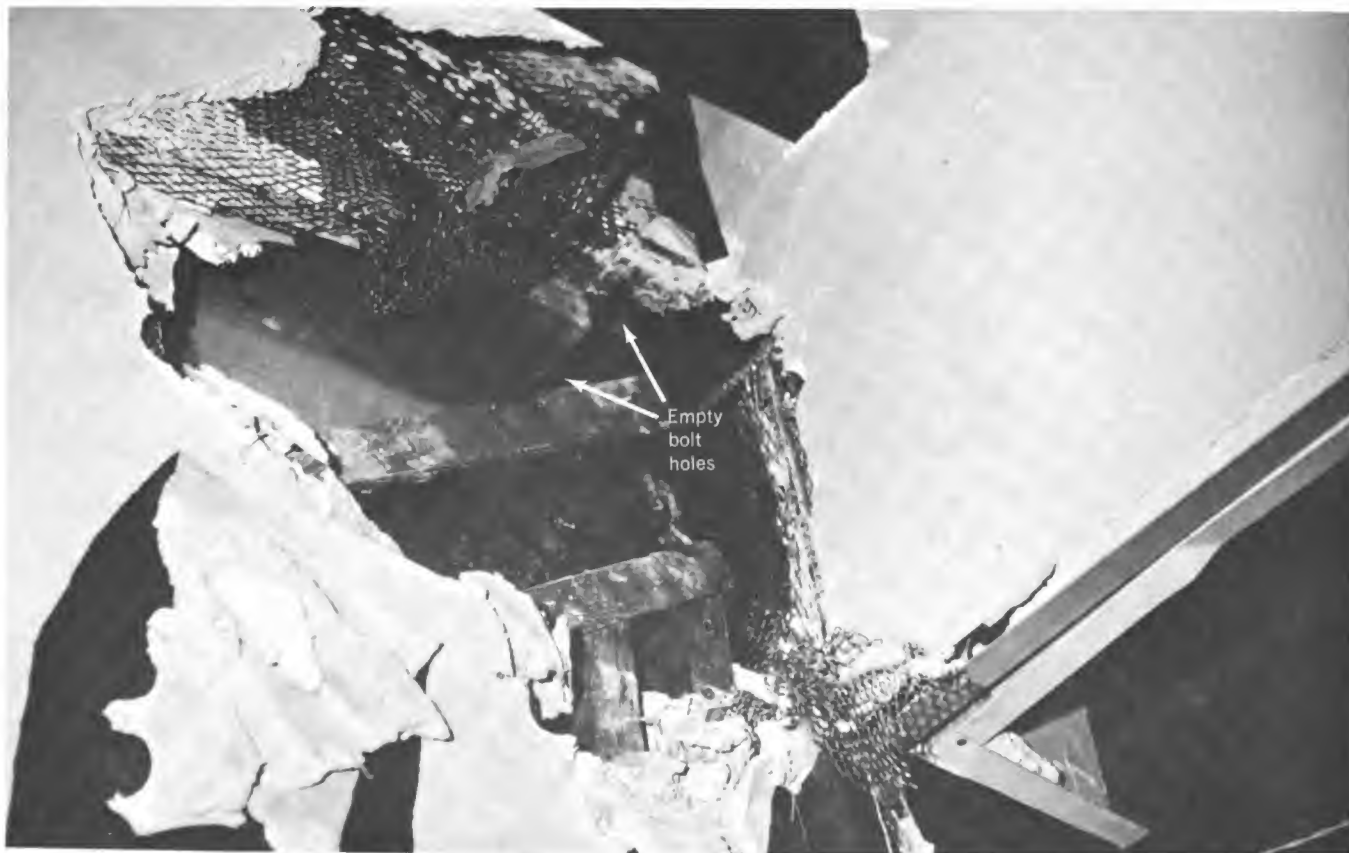
*Figure 8.—Foothill Medical Center. Connection underneath second floor on line 3 at line C. Note empty bolt holes to bottom flange of beam. Loring A. Wyllie, Jr. photograph.*

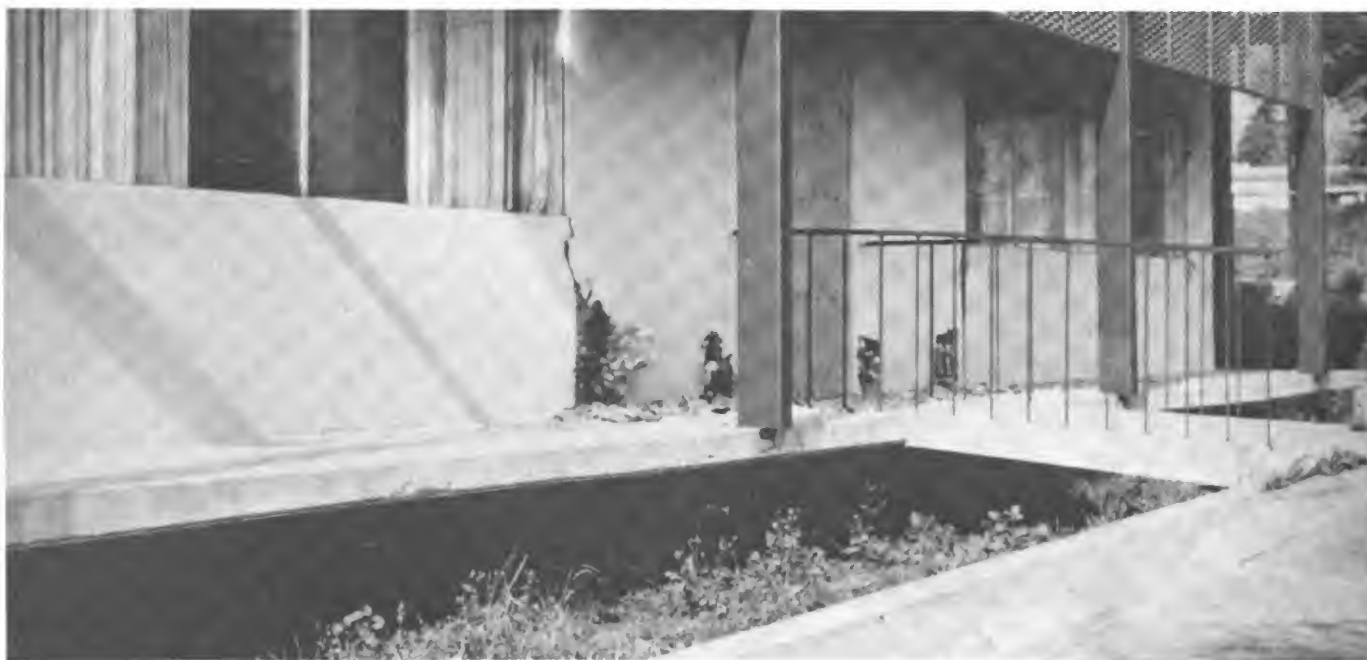
*Figure 9.—Foothill Medical Center. Rear or south end of building, showing plaster damage at base of columns on line 11 at bracing. Loring A. Wyllie, Jr. photograph.*

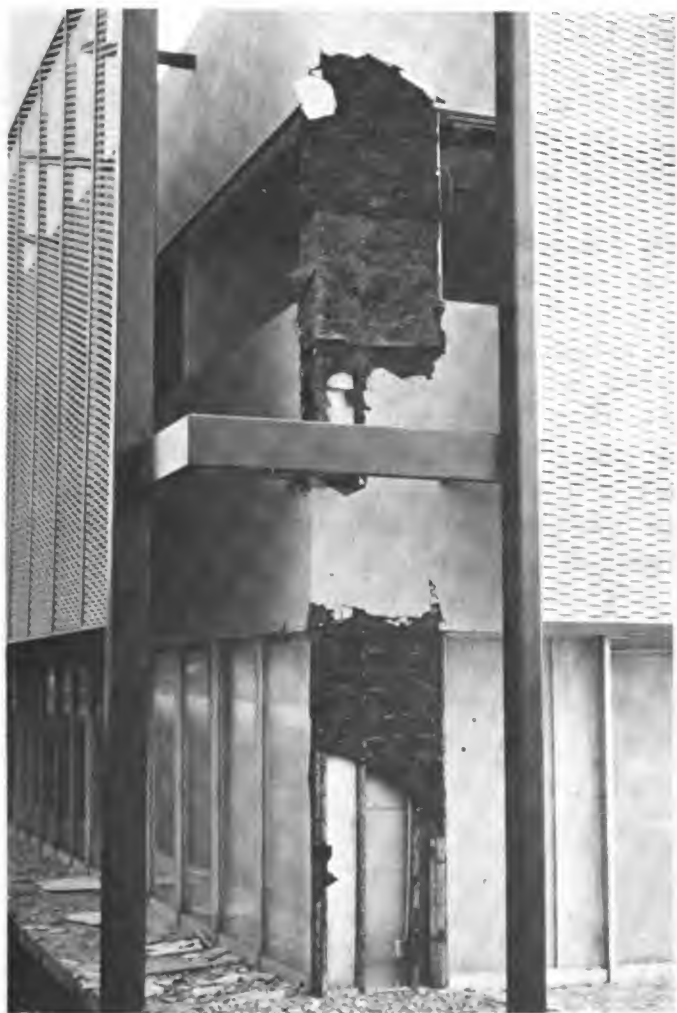
Figure 11.—Foothill Medical Center. Exterior of building at north corner showing plaster and glass damage. Loring A. Wyllie, Jr. photograph.

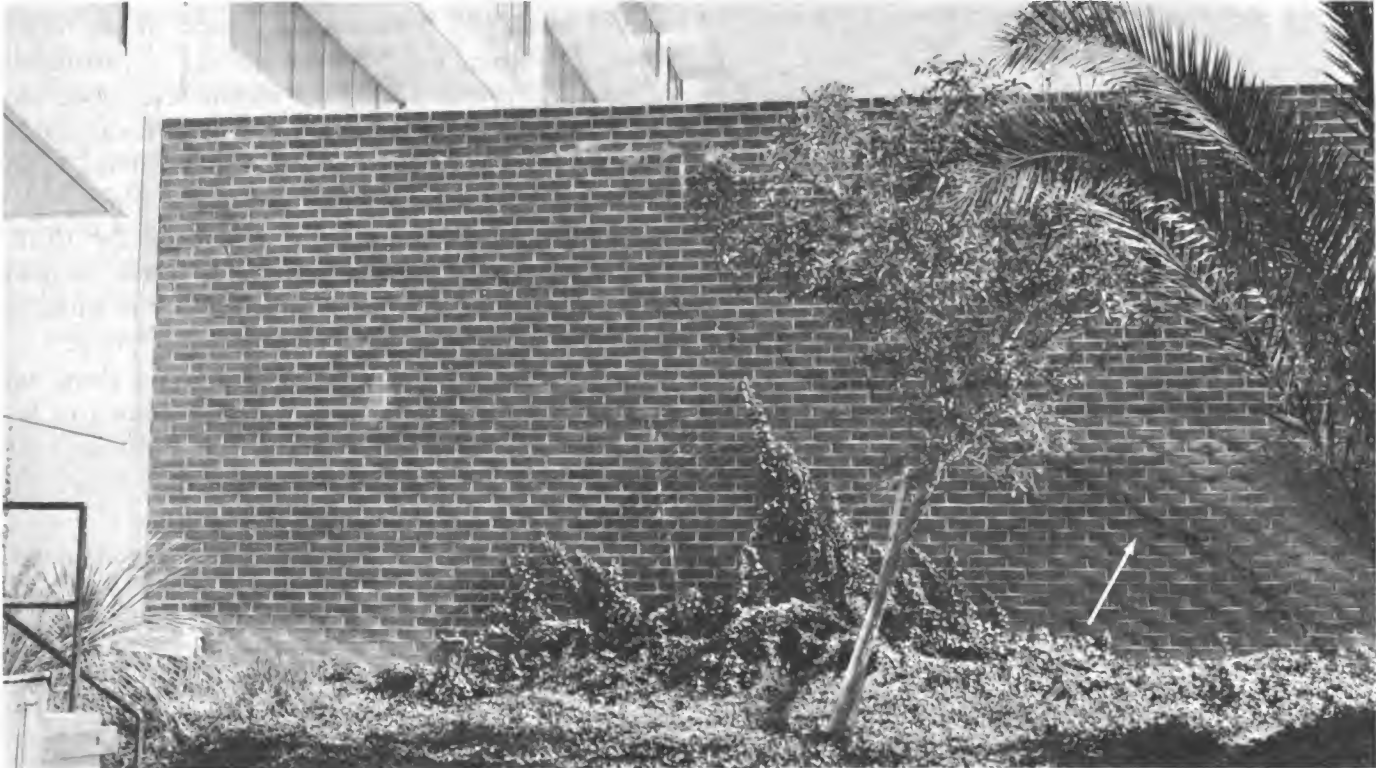
Figure 9.—Pacoima Memorial Lutheran Hospital. Grouted brick wall at west end of cafeteria-mechanical unit. Note diagonal crack shown by arrow. Paul Fratessa photograph.

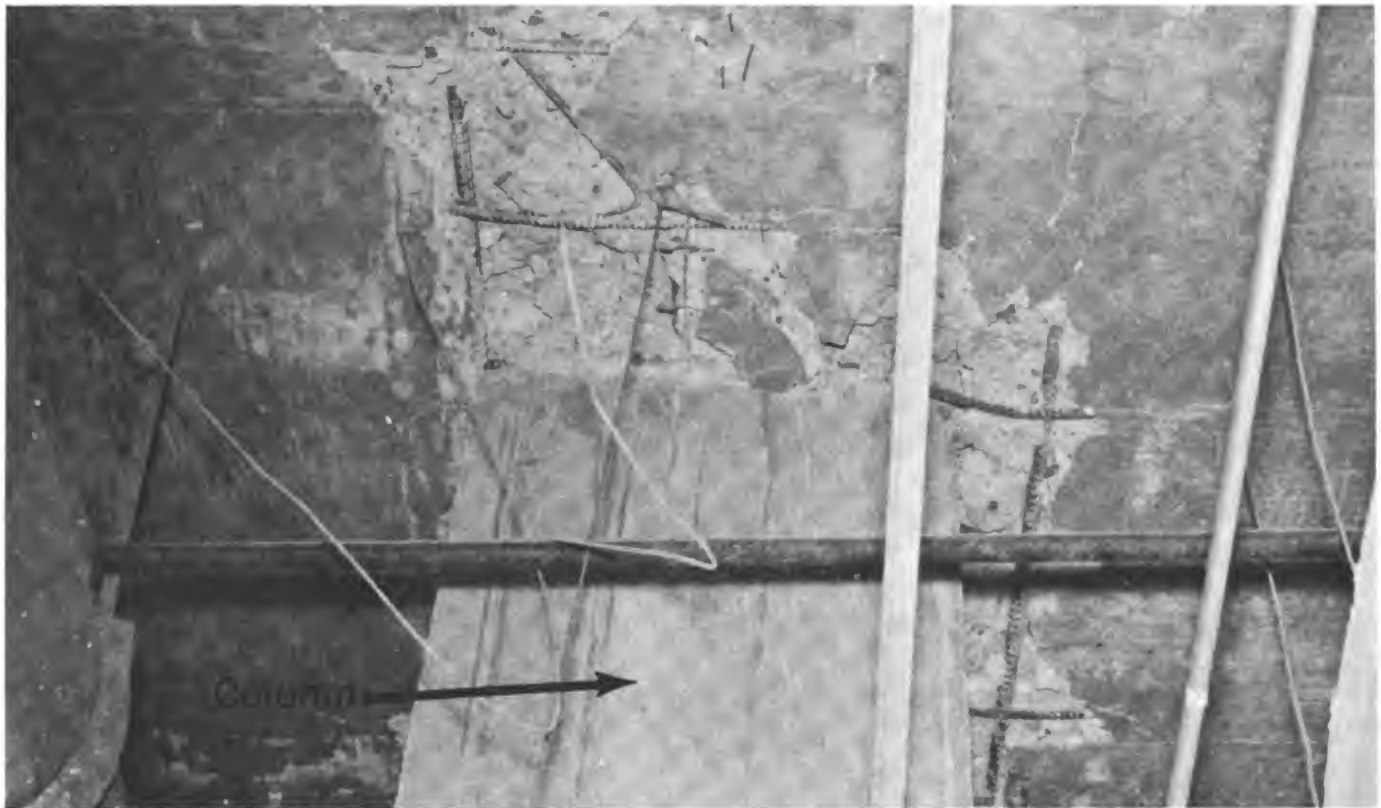
Figure 22.—Olive View Hospital, medical treatment and care unit. Spalling of concrete slab under second-floor framing caused by rotation through connection.

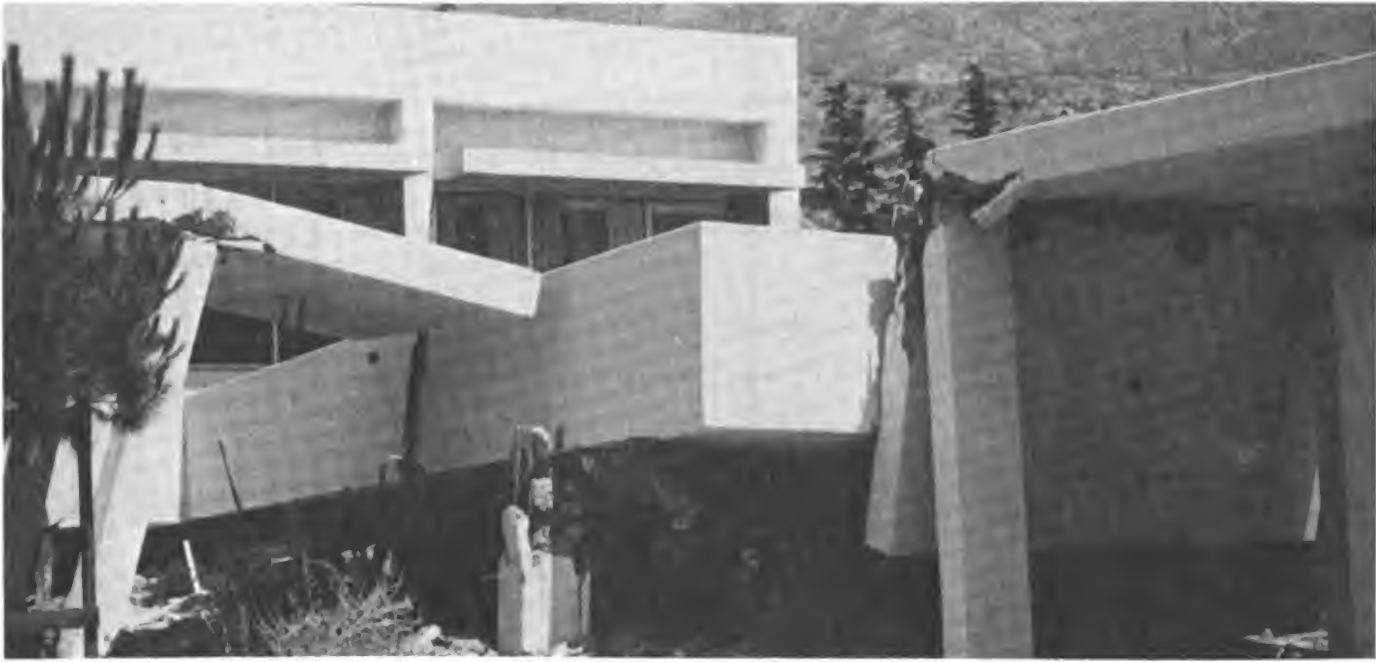
Figure 65.—Olive View Hospital, walkway canopy. Collapse of cantilevered roof, resulting from collapse of psychiatric unit.
